1. Natural Marble replacement guidelines for Bellissimo A, B &C

2. AgglomeratedMarble/Tile replacement guidelines

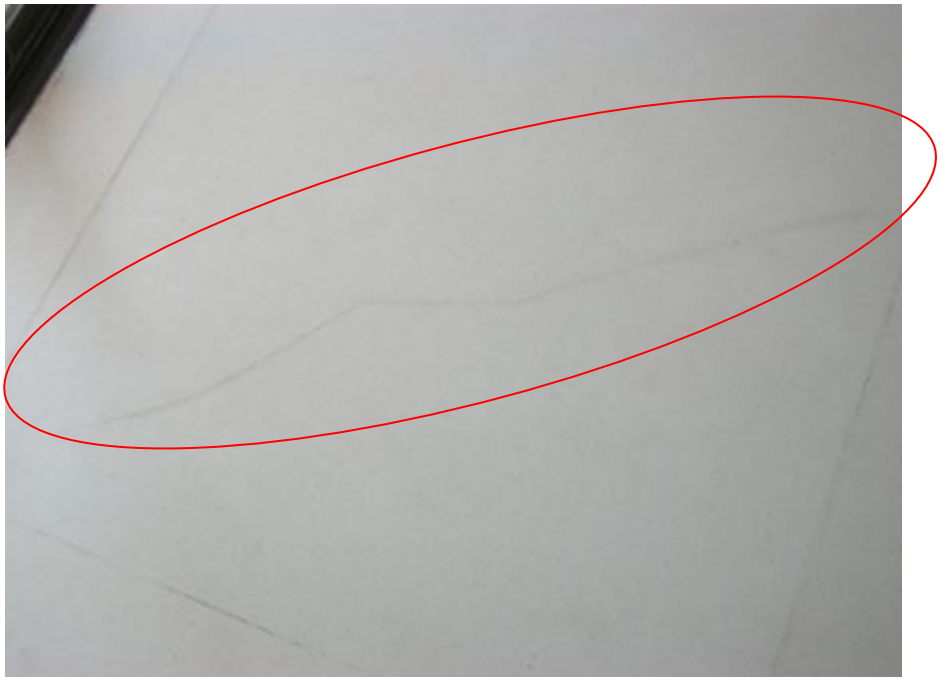
1. One crack of length greater than 10 inches and width greater than 3 mm (see figure 1)
2. Three or more cracks of length greater than 5 inches and width greater than 3 mm
3. Major shade variation (similar to figure 2)which is visually apparent and **significantly aesthetically displeasing** and located in a prominently visible location

Figure 1: *Single crack > 10 in.in length and 3mm in width in agglomerated marble /tile*

2. Such marble/vitrified tilesshould be replaced with new marble from the buffer stock with same shade **before** final inspection and handover of the flat to HFM.
