B6 2nd Floor Struc. Plan
27/5/19

R.C.C. 2ND FLOOR PLAN
TYPE B6

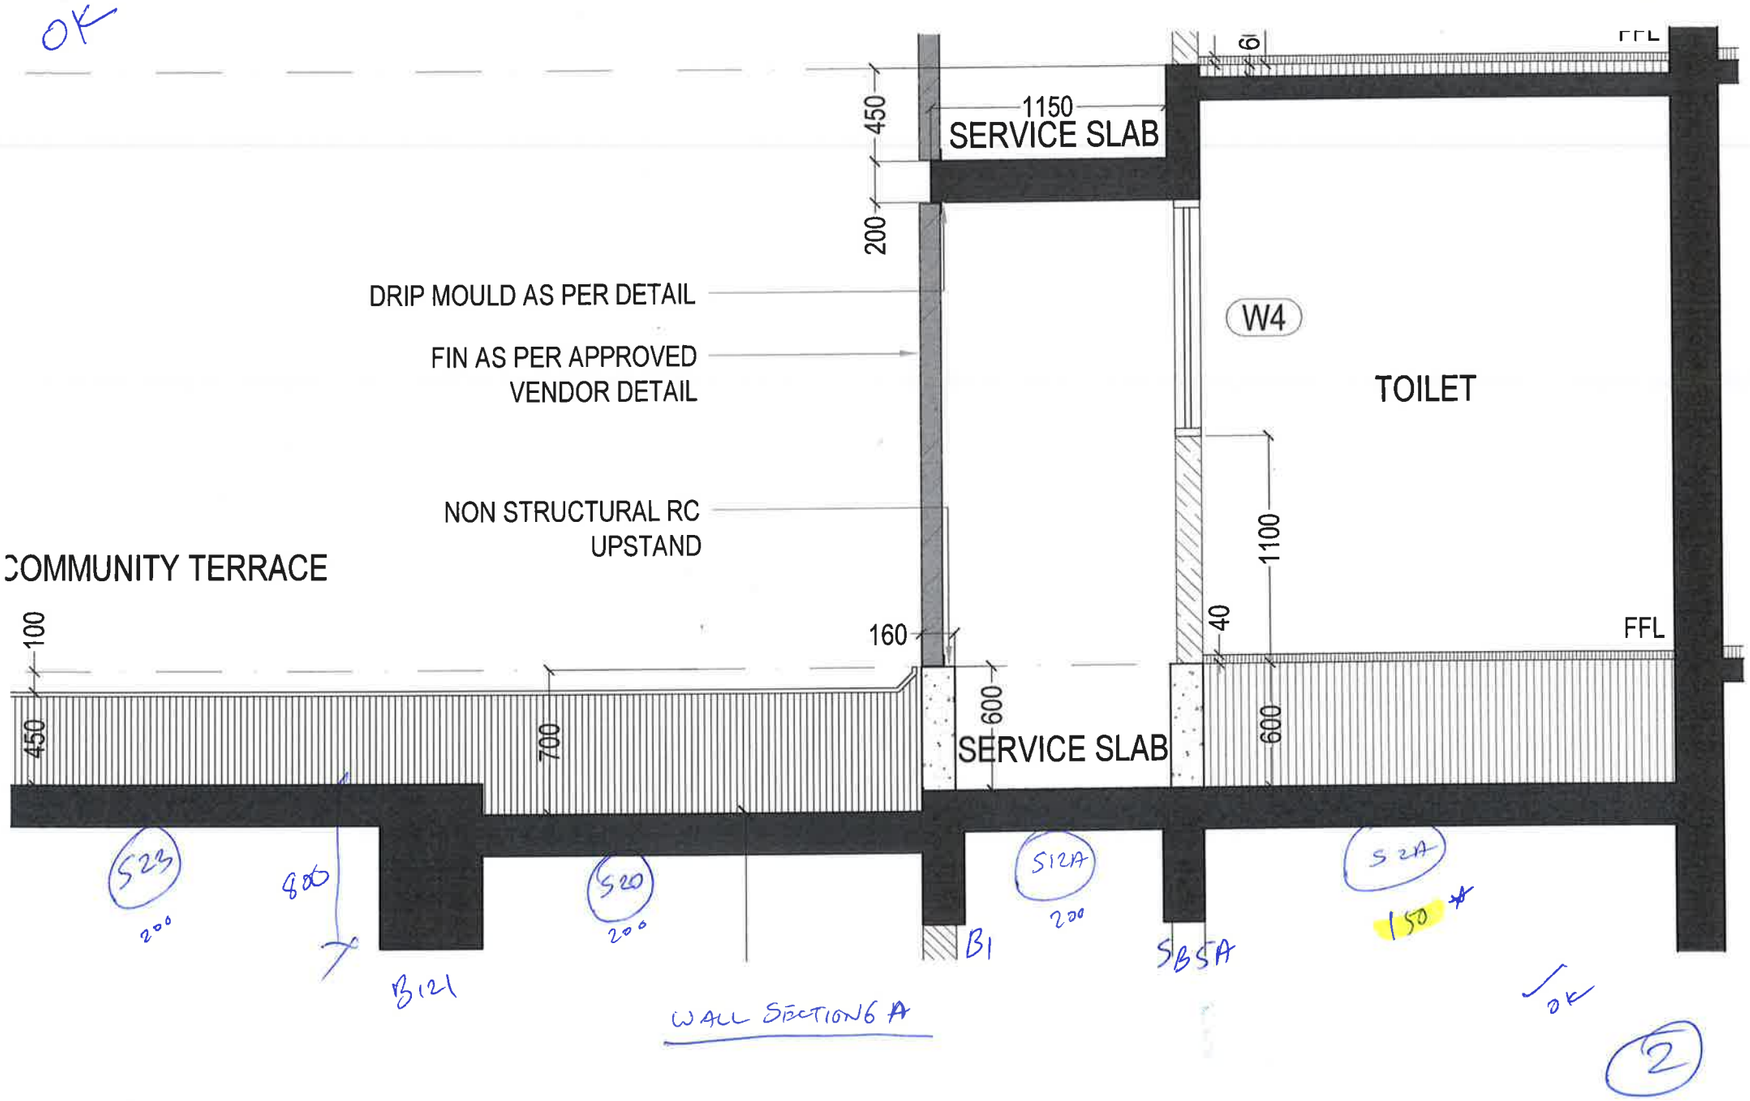
B6
2nd floor
27/5/19

OK

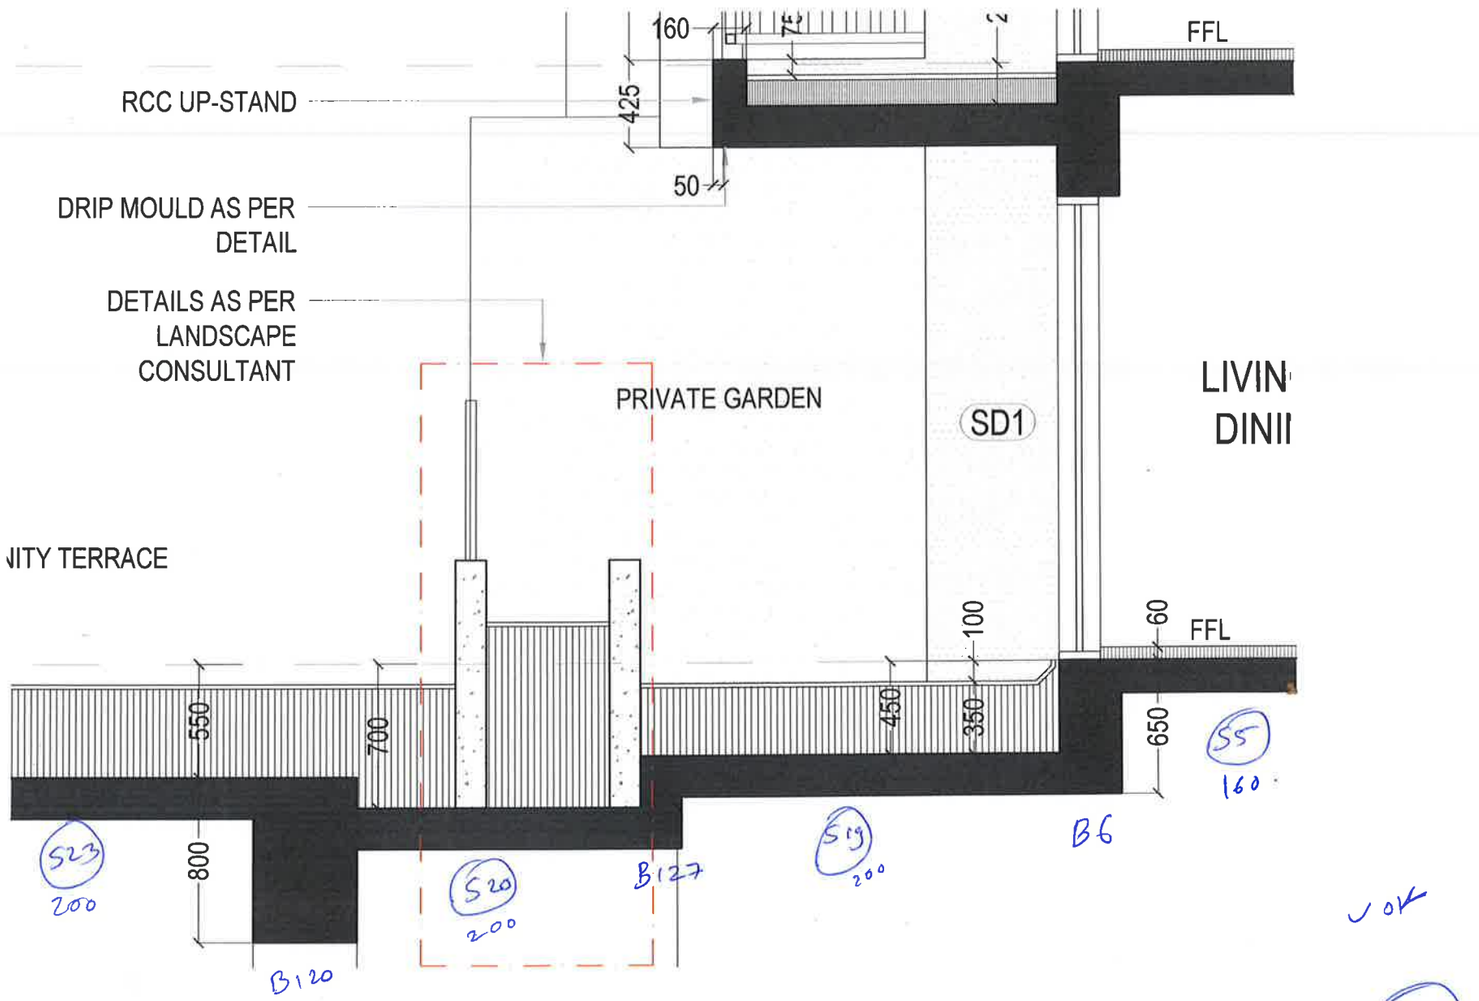
B6
2nd floor
27/5/19

OK

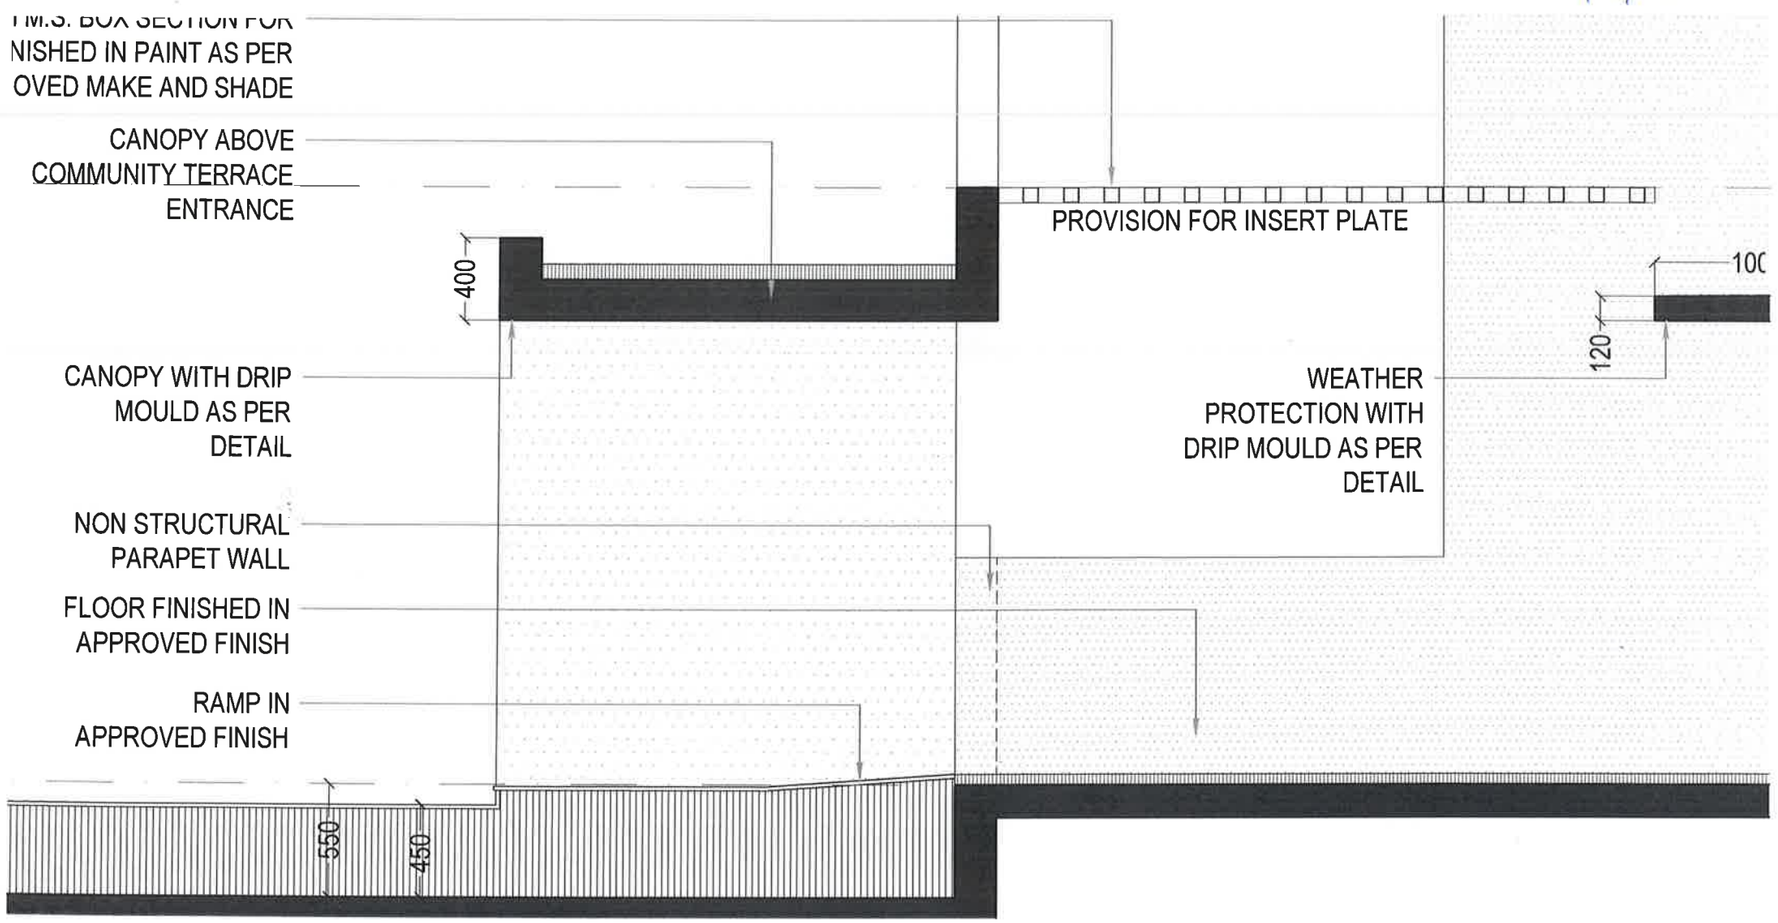
TERRACE ENTRANCE
200
400
KAPL to confirm
DRIP MOULD AS PER DETAIL
2250
100
COMMUNITY TERRACE
550
450
EXTENT OF
STAIRCASE BEYOND
FIRST FLOOR
500
W5B
W5C
1450
800
1450
B13
B6
@ 1st floor
11
10
9
8
7
check for water ingress.
Non. struct wall.
B13 650 Deep.
Non. struct wall.
KAPL To check
B6
2nd floor
27/5/19
WALL SECTION 14
3

KAPL & SBC to check

SBC To Check Beam Top Sunk in plan & change hatch accordingly.

KAPL LINE SEEN IN ELEVATION

COLUMN ST1 TO TERMINATE BELOW STRIP SUNK LEVEL AT COMMUNITY TERRACE.
