STATUS REPORT

Project **Palava – Sector 03.**

Subject 2nd floor slab checking for Primia J wing conducted on 03-Dec-2014.

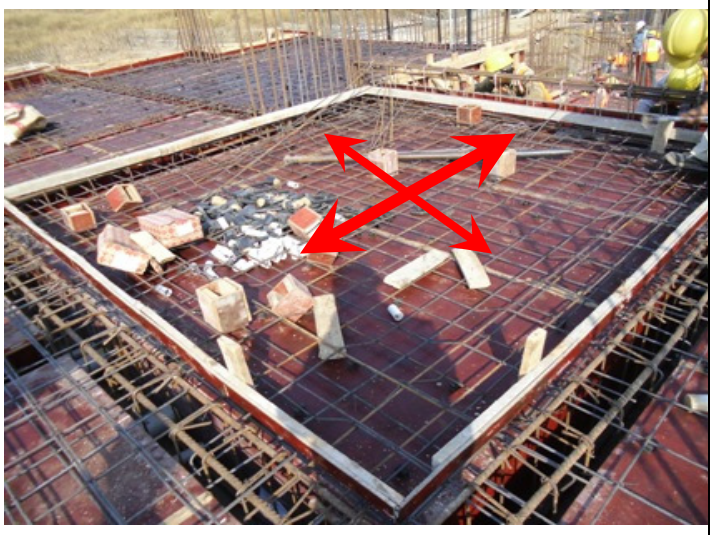
Sr. no	Area / Location	Images	Comments\ Observations	Recommendation
1	Toilets Sleeves @ units 1, 2, 3, 4, 5&6.		Toilets sleeves are Work in progress in all units.	To be provide as per drawings.
2	Utility Sunk @ units 1, 2, 3, 4, 5&6.		Side shuttering is in progress in all units	To be rectified as per drawings.

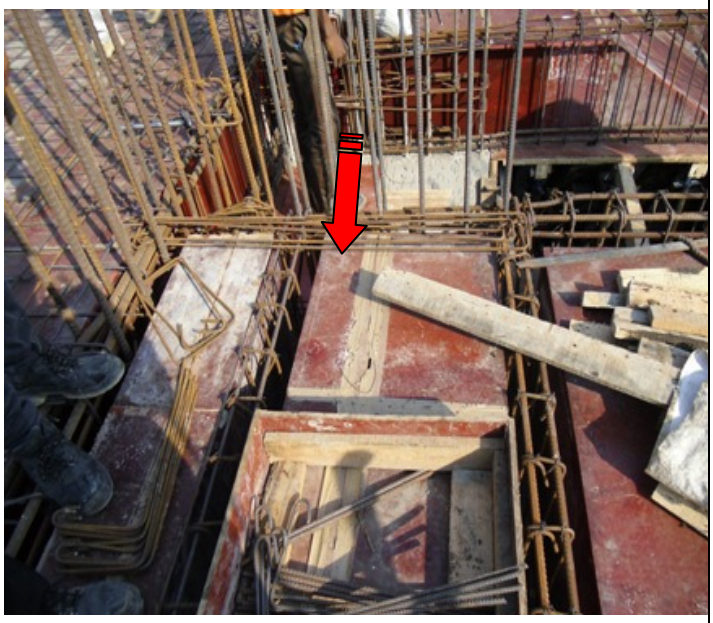
Sr. no	Area / Location	Images	Comments\ Observations	Recommendation
3	200X200 mm cutout @ staircase 02		200X200 cutout near firefighting duct to be provided	To be provide as per cut out drawings.
4	Terrace slab @ unit 02		200X200 cut out alignment should done properly	To be provide as per cut out drawings.

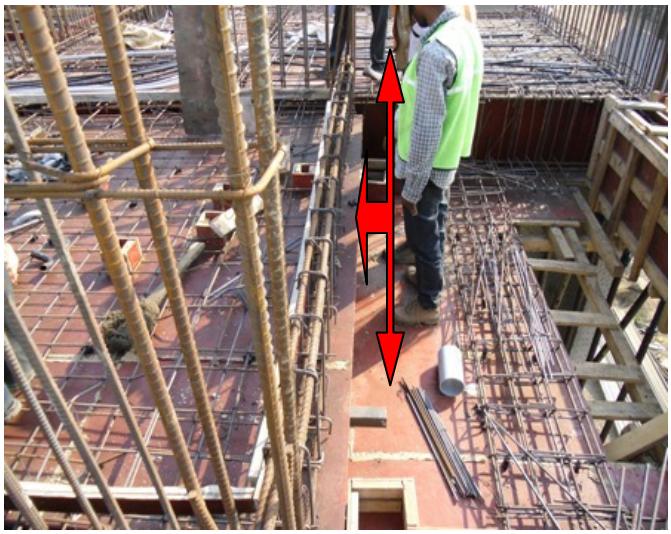
Sr. no	Area / Location	Images	Comments\ Observations	Recommendation
5	Service slab chajja @ unit 3&4.		Chajja in service area to be provided	To be provide as per drawings.
6	Toilet alignment @ all units		Alignment in toilets are in progress	To be provide as per drawings.
