PREMIER SALES GALLERY

SITE VISIT ON 2021-11-29

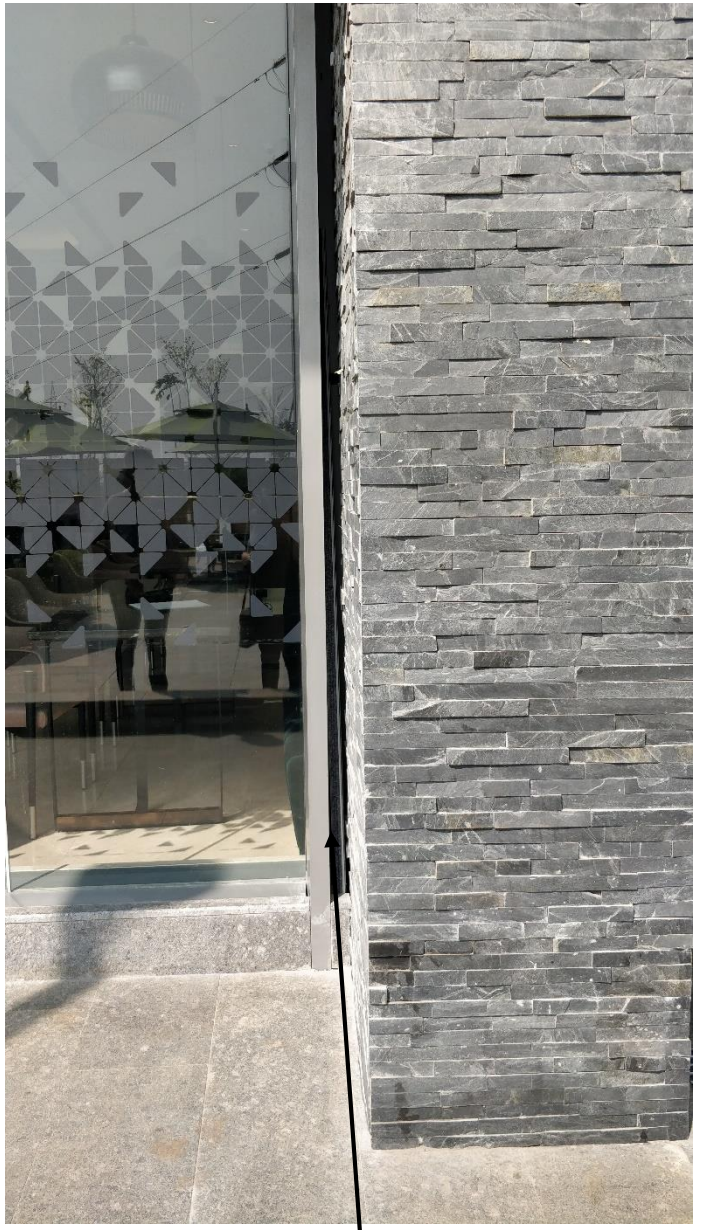
Frame welding to be cleaned and polished finished with RAL 7024/ matching to the façade cladding
Cladding has been broken at the tie member junction
Glass to be cleaned

Ideally same cladding and fin to be continued till floor

Gap to be cleaned and maintained properly.
Façade team to confirmed if that can be sealed/ filled

Stain marking to be cleaned

This walls to be painted with same shade of exterior round columns

To be packed with exterior grade bison board finished with paint

All these base stone to be cleaned and painted

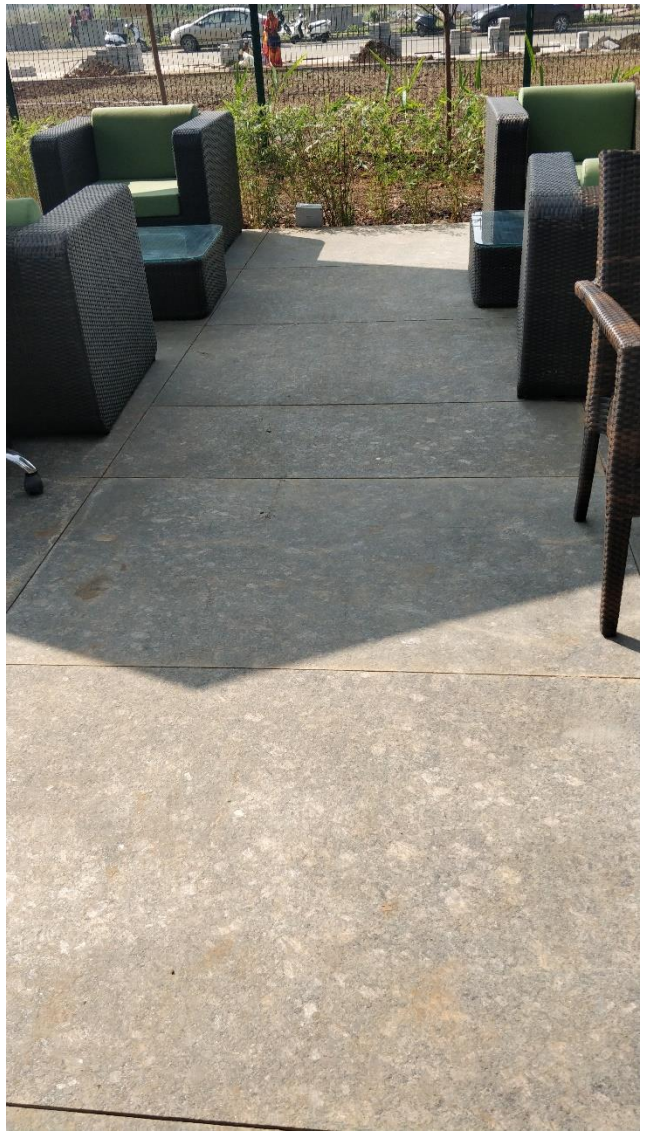
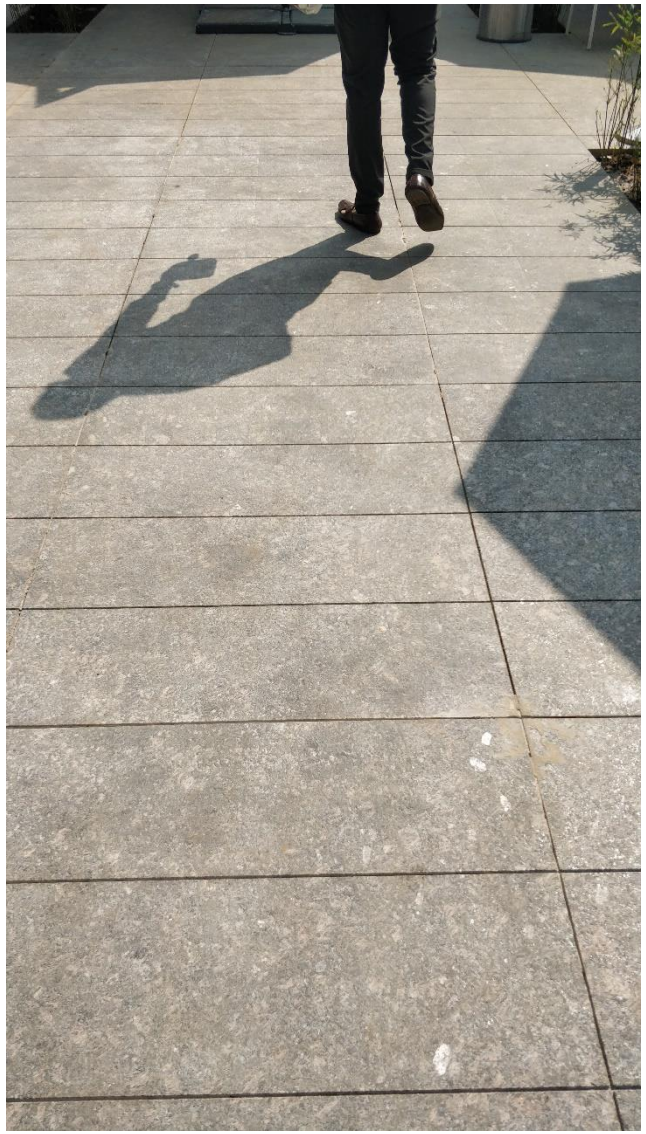
Pebbles are missing at rear side. Refer Landscape drawing for the extent

Offset at the bottom of the cladding to be min. tile thickness only. Please rectify.
Plinth protection to be continued all across.

Tile joints are not as per drawing. Please follow flooring pattern as per drawing.
Joints to be filled with grout matching to the granite.

Lawn to be added between the gaps of the steps

Gutter is visible from the distance,
please rectify.

Edge detail given but not executed , hence border started cracking. please rectify.

Cracks started developing in the parking area

Broken plinth protection tile to be replaced.

Civil work to be finished and painted around the pipe. Pipe to be concealed in the soil and plinth protection tile to be continued.

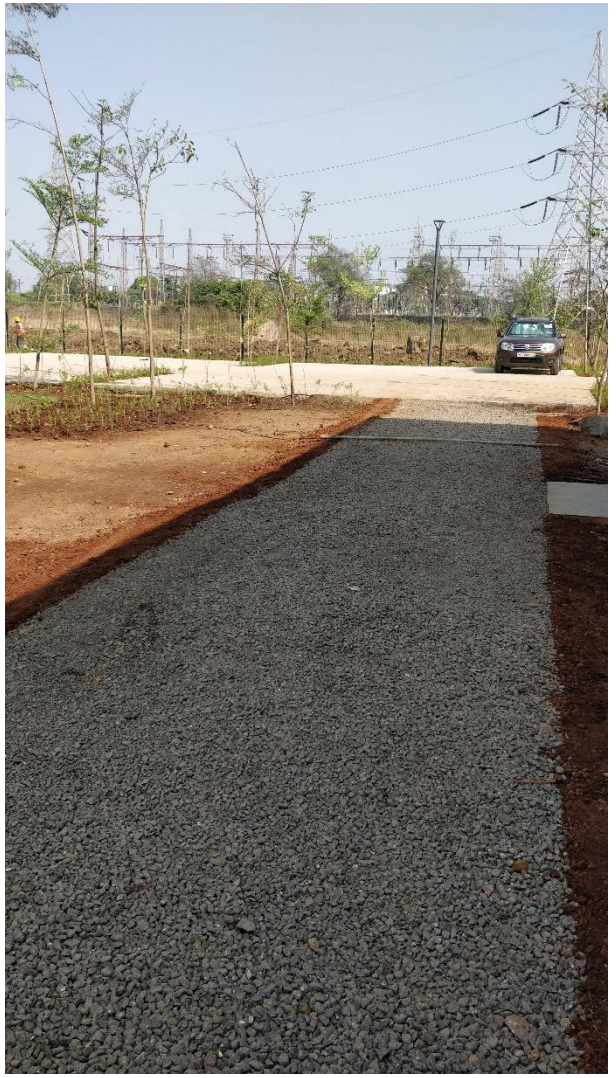
Aerator pipe need to be below water level

Soil alignment to be same across the plinth protection line.
Drop of plinth protection is missing

This are plantation is pending.

Charu walkway and plantation is pending.
